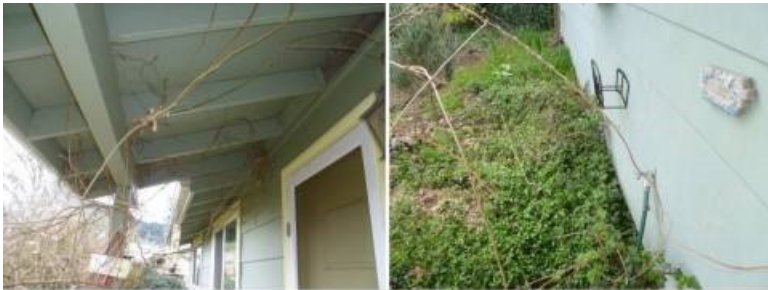
(C) Bushes and shrubs need to be trimmed away from the structure at least 2 inches. This space is needed to prevent direct access to the structure by insects and to keep the bushes from damaging the siding. Recommend correcting this condition(s).

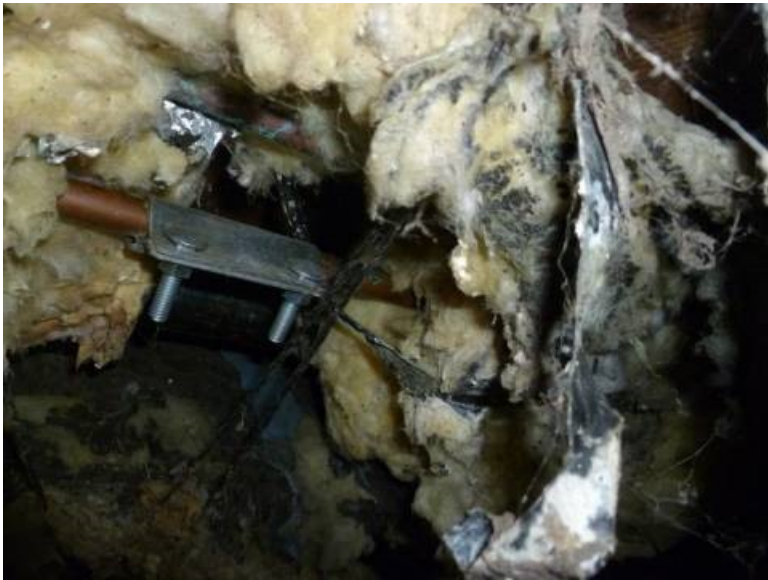
Past temporary repair noted, Recommend monitoring this condition.

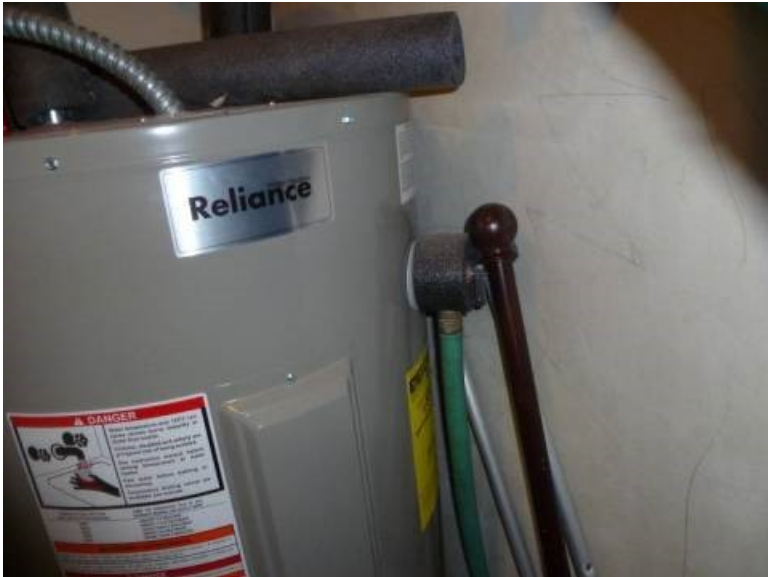
(S) The drain pipe was routed in a non approved material. This condition is a safety hazard. Recommend correcting this condition(s).

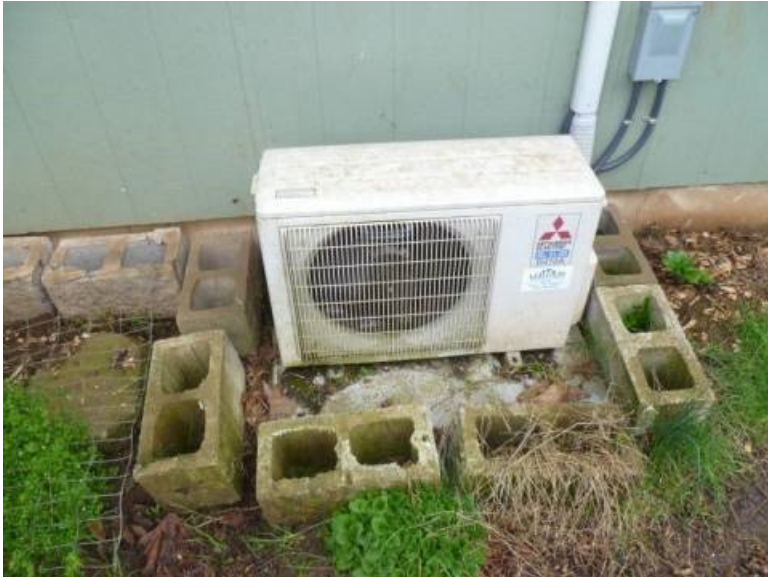
**Model/ Serial Number/ Size:**

Condenser unit Location- Rear of building.
