Inspection: 18009

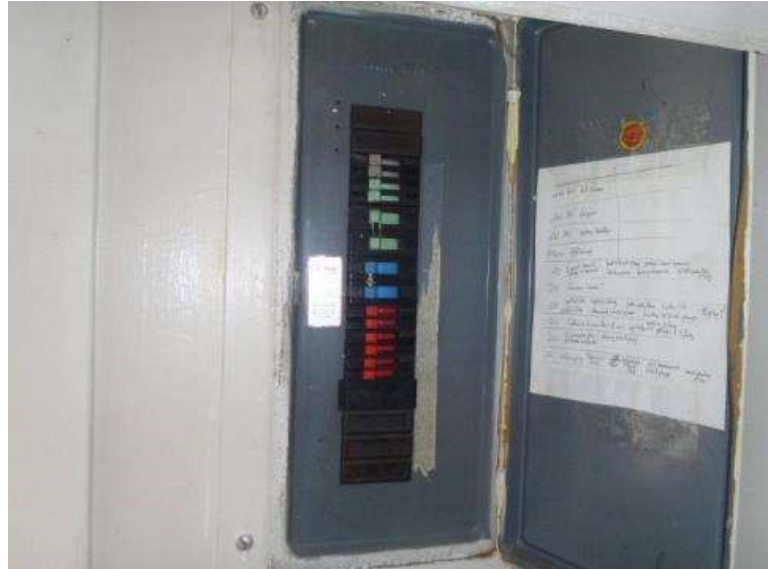
(S) A Zinsco or Sylvania-Zinsco brand electrical panel is installed in this building. Serious electrical hazards may be present in the panel which could result in overheating, fire, or inability to turn off the electric power in the home. We recommend a full evaluation by a licensed electrician who is familiar with this equipment. The panel should be replaced. Additional information about this hazards is available at an independent building failures research website. [www.inspect-ny.com/electric/Zinsco.htm](http://www.inspect-ny.com/electric/Zinsco.htm).

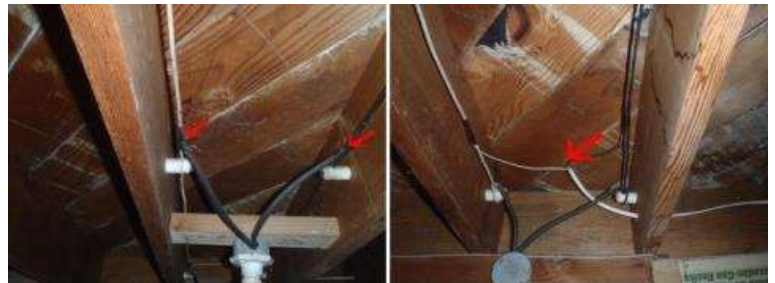
(S) Exposed splices not contained in approved junction box noted. Recommend further evaluation/corrections by a licensed Electrician.

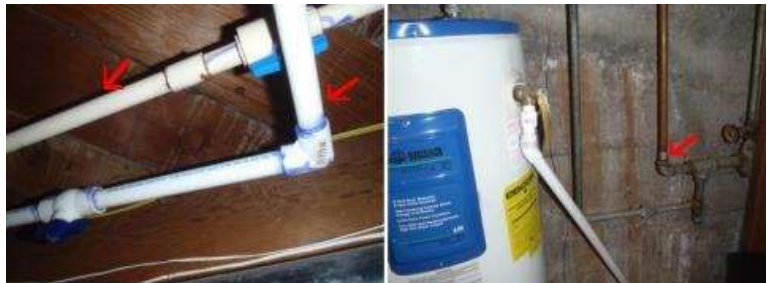
(C) Repairs using pvc pipe noted. This is not an approved material for house distribution. Recommend further evaluation/corrections from a licensed plumber.  
(M) There were copper to galvanized connections noted. This condition can promote corrosion through a process called electrolysis. Recommend monitoring this condition.

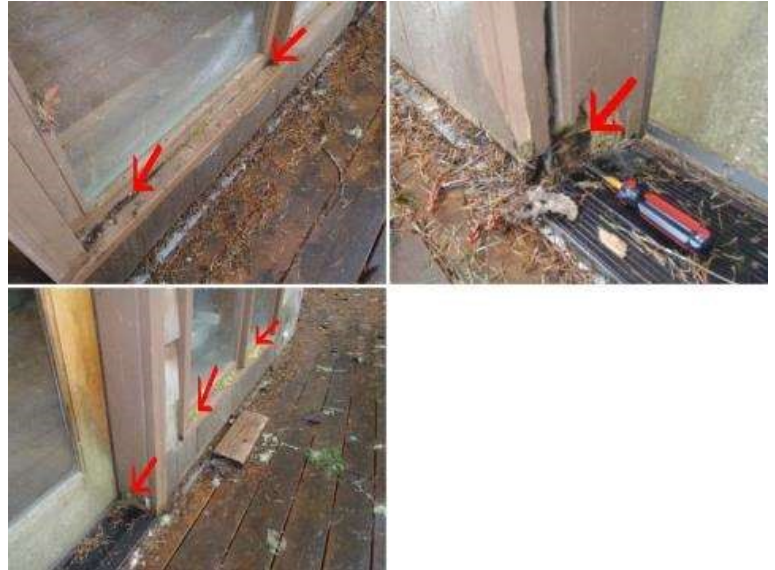
(C) Dry rot found in the north side window and door trims. Recommend removing damage wood, inspecting for hidden damage and/or pest infestation and replacing with new material. Recommend correcting this condition(s).

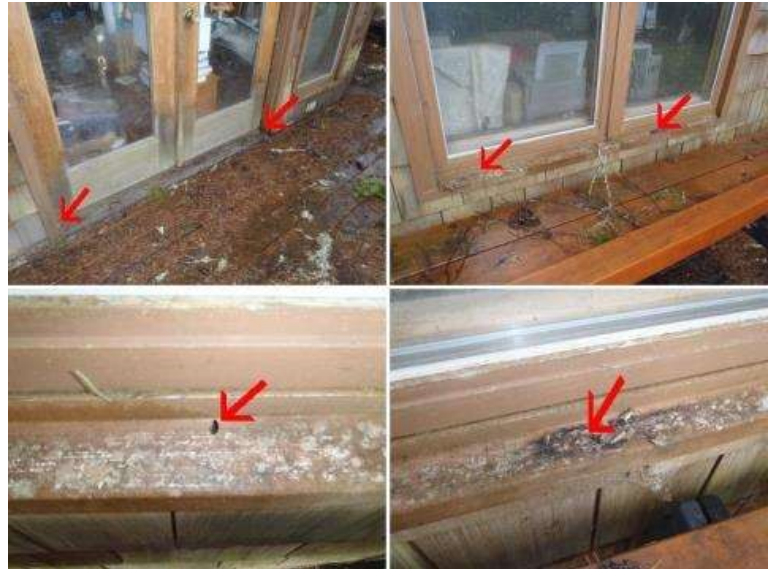
(C) (E) More dry rot and bore holes noted in the trim of the den windows. Recommend further evaluation by a pest control specialist.

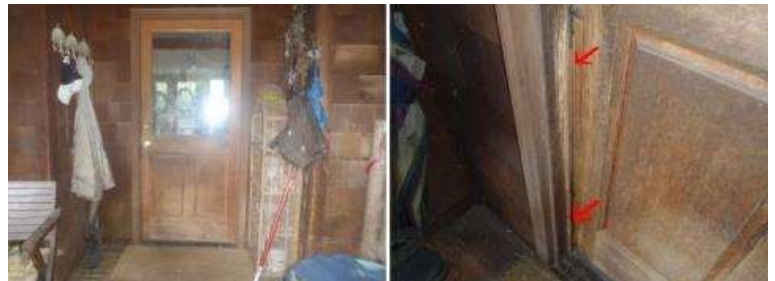
Pet scratches and damaged weather strip noted.

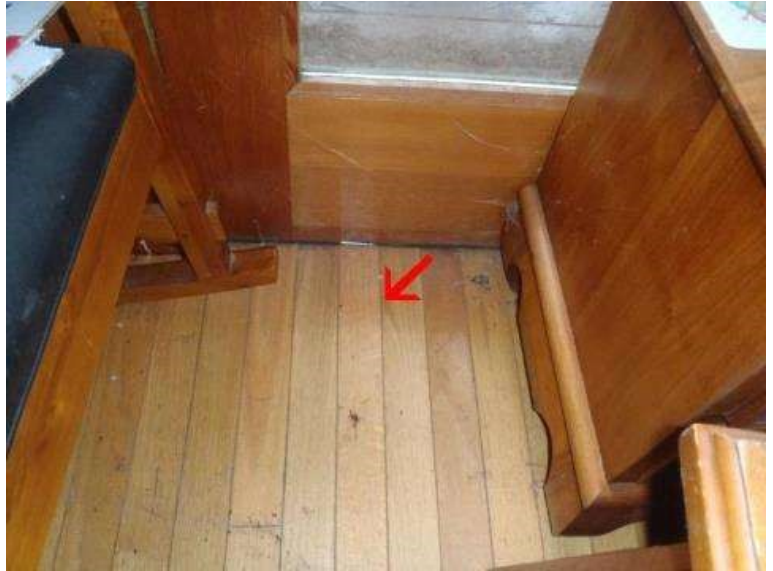
(E) The floors are in functional condition except a high moisture reading was observed and swelling noted near the left side of the doors. Poor weather strip at bottom door? Recommend further evaluation/corrections from a qualified specialist.

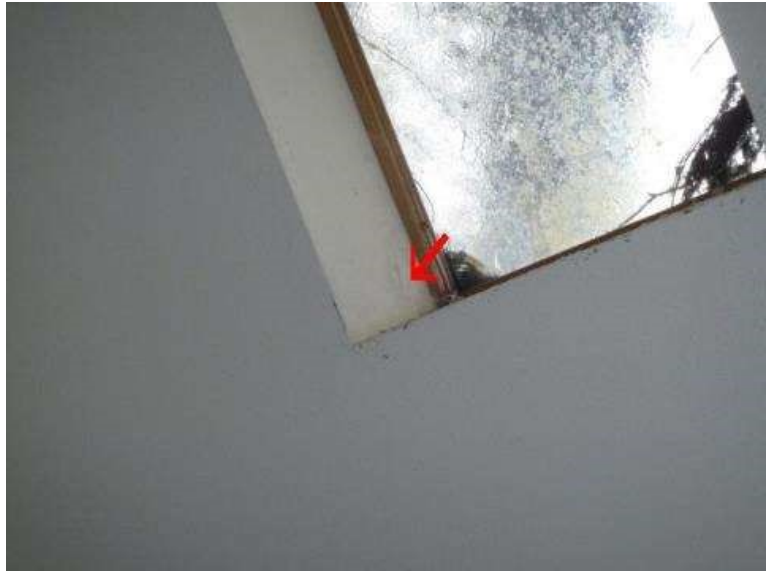
(E) Some paper lift near bottom of skylight noted. No stains noted. Past leak? Recommend further evaluation/corrections from a qualified specialist.

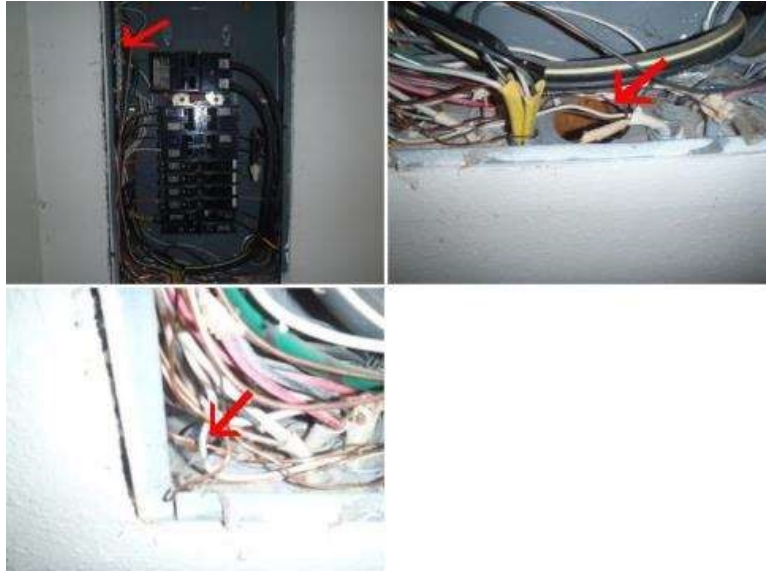
(S) The ground and neutral wires are on the same bus bar. The ground wires should be connected to a separate non isolated bus bar. Recommend further evaluation/corrections by a licensed Electrician.

(S) Missing knockouts notes. This condition may allow mice access. These conditions are a safety hazard. Recommend correcting this condition(s).

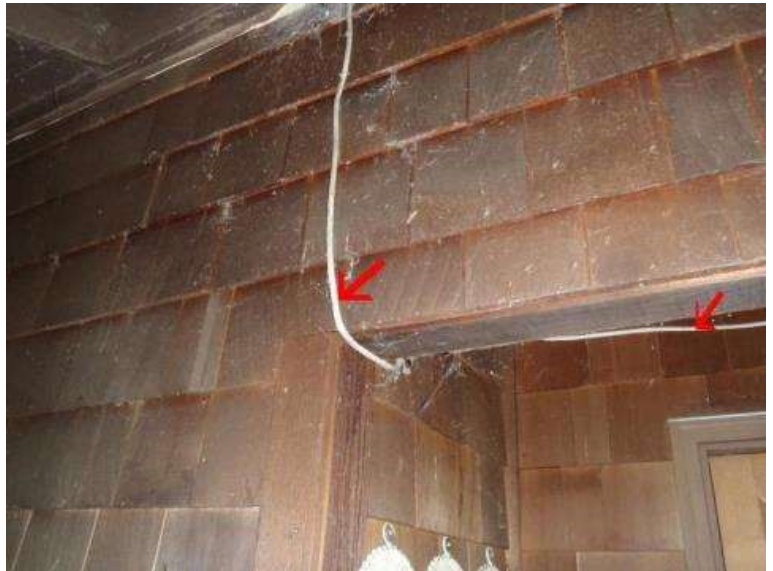
(S) Exposed romex wire at the front porch noted. Recommend further evaluation/corrections by a licensed Electrician.

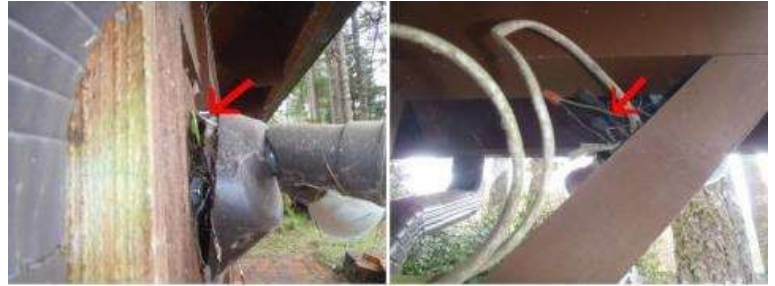
(S) The exterior lights at the house and carport are not connected to an approved electric box. This condition allows the wires to be in contact with adjacent materials. This condition is a safety hazard. Recommend further evaluation/corrections by a licensed Electrician.

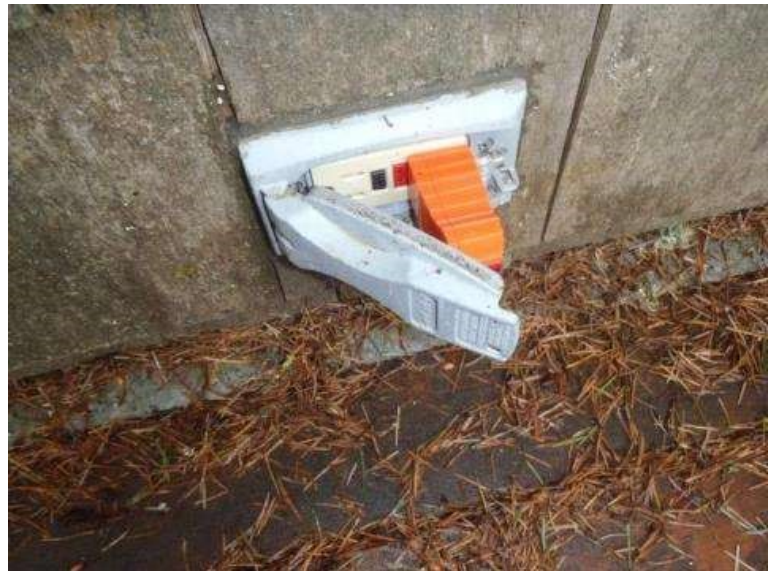
(S) The Exterior GFCI outlet at the family room would not trip when the button was pressed. Its needs replacing.

(E) The exterior outlets near the den were functional but not determined if GFCI protected. Recommend further evaluation/corrections as needed.

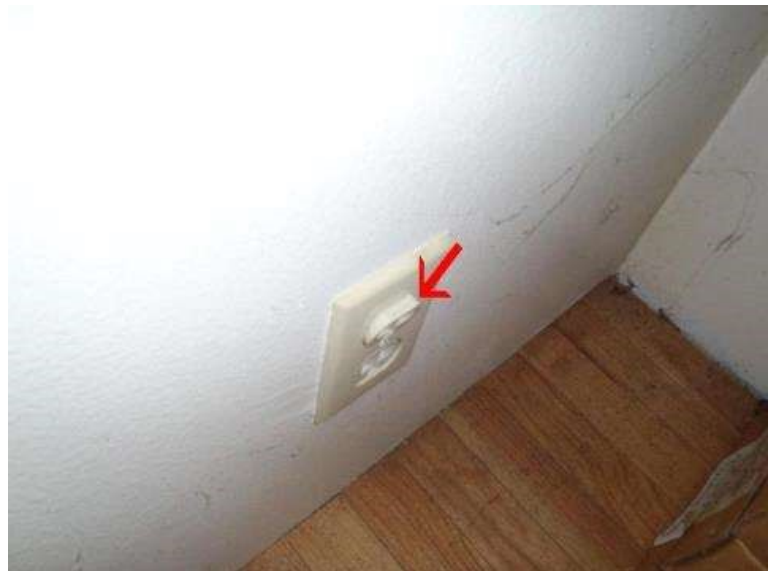
(C) The receptacles were functional except the upper receptacle housing is loose. Recommend replacing. Located right of doors.

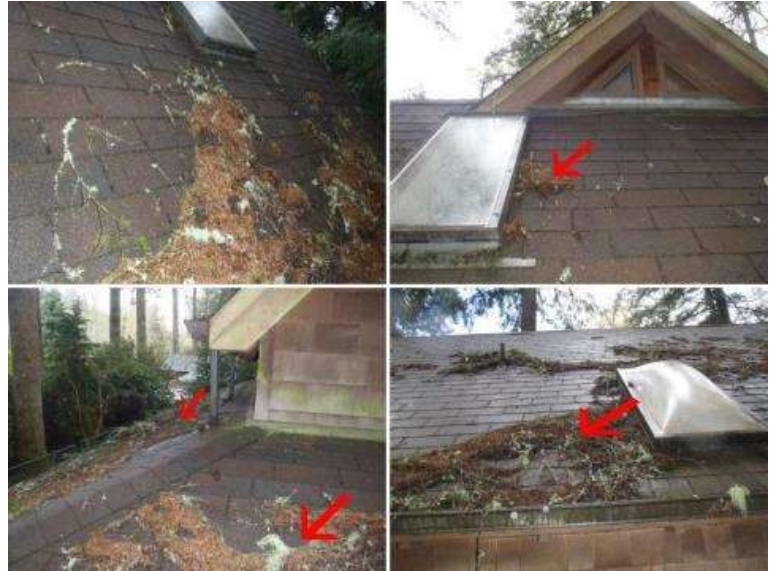
(C) The roof covering material is in a condition that is consistent with its age except due to large amounts of tree debris. The roof inspection is limited. Hidden damage may exist in these areas. Recommend cleaning roof and a follow up inspection performed.

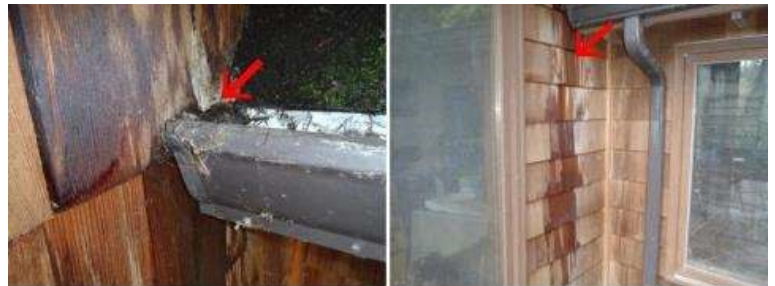
(C) There is no diverter flashing installed where the runoff is coming down the wall. The shingles are showing sign of deterioration due to this condition. Recommend correcting this condition(s).

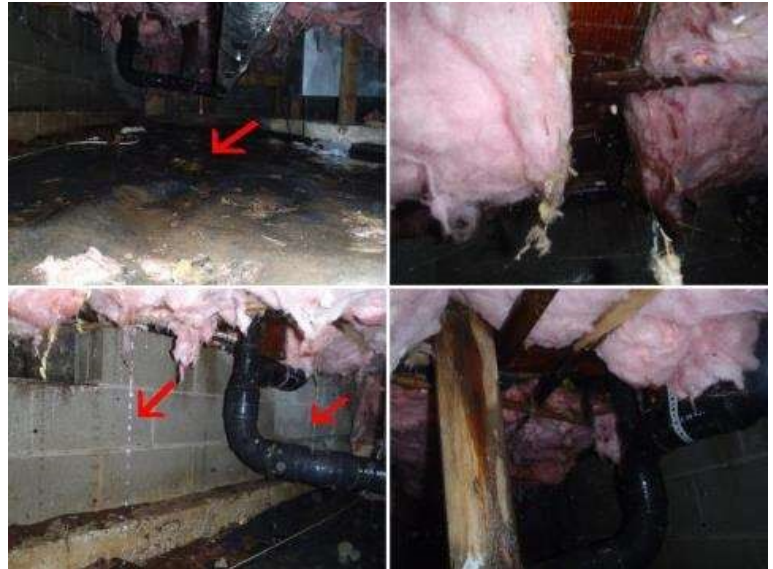
(C) A significant leak under the bathroom or water heater closet noted. The moisture is affecting the subfloor and insulation, interior walls and draining into the crawlspace. Recommend further evaluation/corrections from a licensed plumber and further evaluation/corrections from a licensed contractor for subsequent repairs.

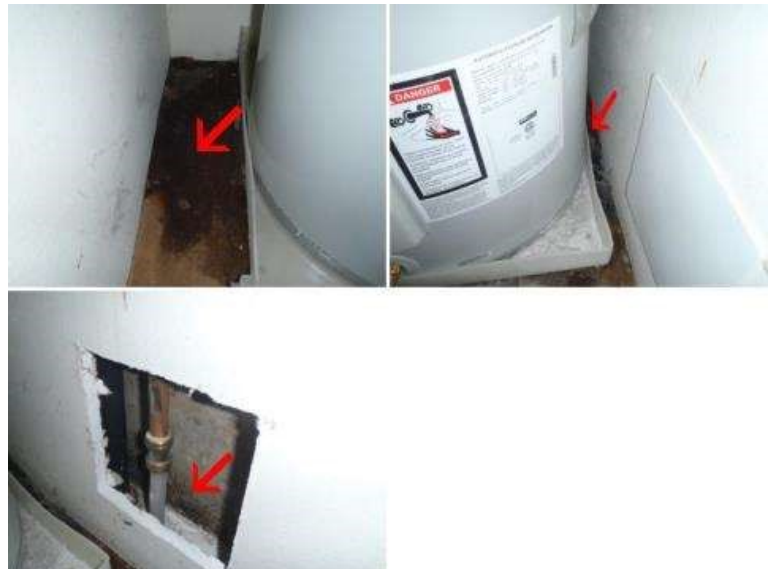
(C) The floor under the pan is wet and the wall at the repair appears to be moist with fungus/mildew noted. See plumbing section. Recommend testing or removal if concerned and further evaluation/corrections from a licensed contractor.

Note: the hot water tank breaker was off at beginning of inspection. Owner turned on breaker but water temperature was not verifiable. Recommend verifying water temperature after water heater has been on for a while. Water temp may have been affected by current leak.

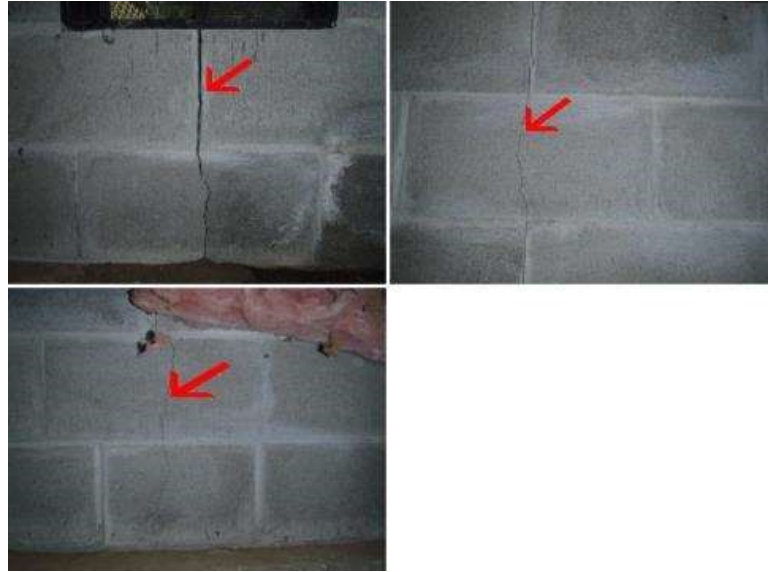
(M) Shrinkage cracking was noted on the east and north wall of the addition side. Shrinkage cracking is the result of moisture in the concrete walls evaporating and shrinking. This generally is not a cause for concern as all concrete shrinks. Should any of these cracks begin to grow, then further attention and evaluation would be recommended. Recommend monitoring this condition.

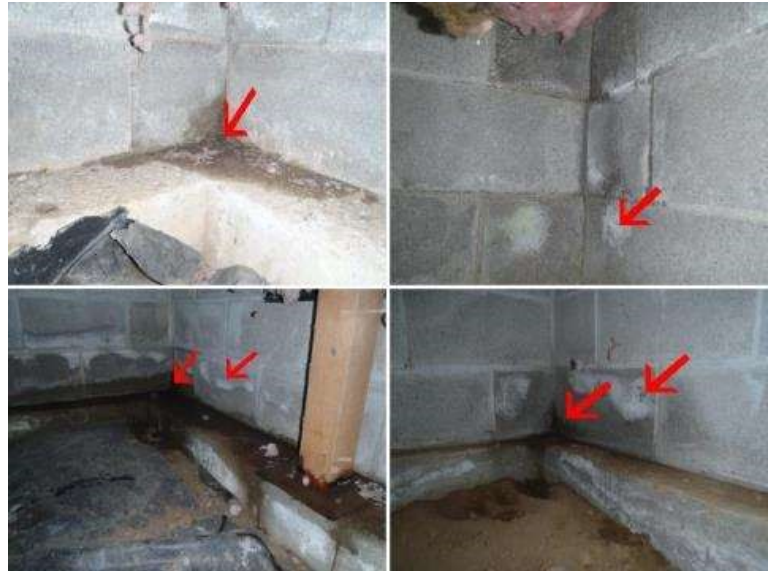
(C) Moisture intrusion noted at the corners. This may be caused by the downspouts emptying next to foundation. See roof section. Recommend correcting this condition(s) and monitoring after downspout corrections made.

(M) Some efflorescence noted on the walls. This is salt deposit left when the wall experiences wet and dry cycles. Recommend monitoring after exterior drainage improvements made.

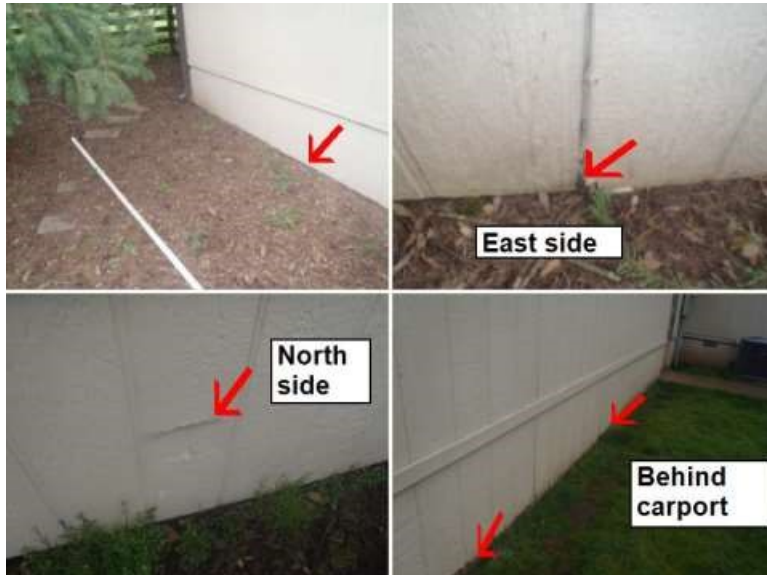
(C) Skirting materials consist of fiber composite panels. There is a lack of adequate clearance to the soil. This inadequate clearance may allow water to wick into the siding and can also hide insect or termite entry. Minor rot and damage is also noted. Recommend further evaluation/corrections from a qualified specialist.

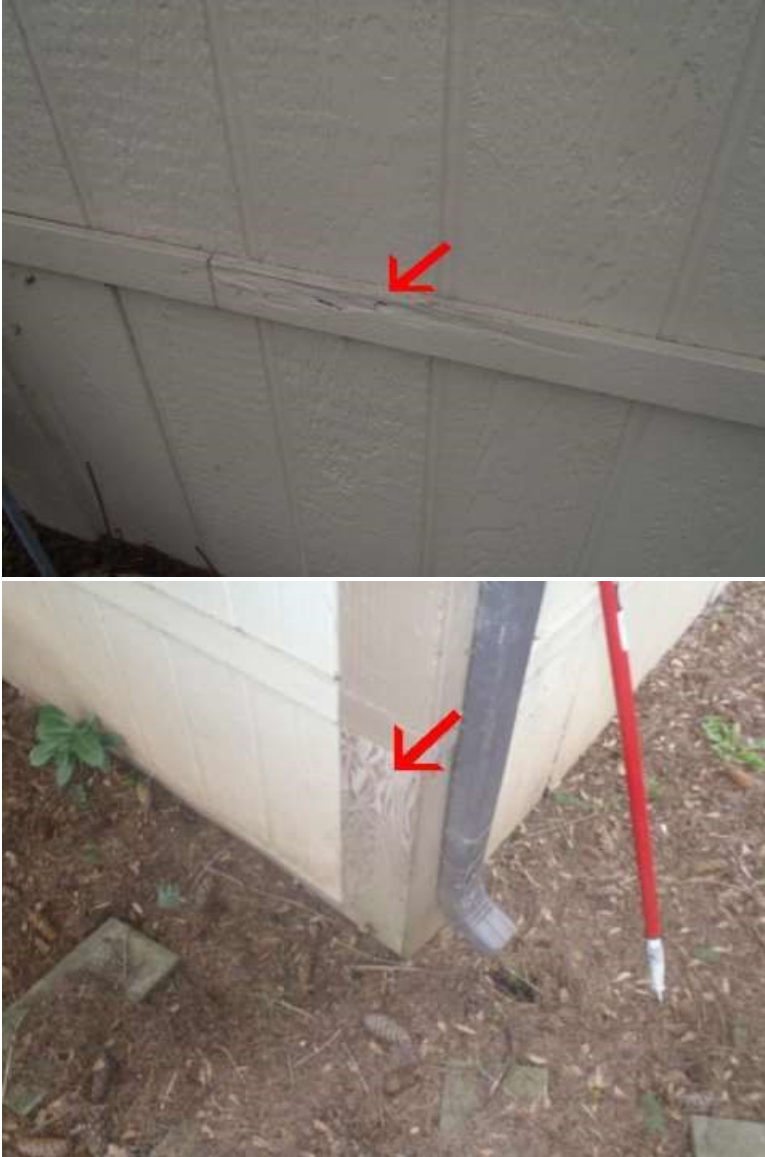
(C) Rot noted on the trim between skirt and siding on north side. Recommend removing/replacing all affected materials. Marked 1 on drawing.

(C) Unpainted corner skirt trim noted and there is a lack of adequate clearance to the soil. This inadequate clearance may allow water to wick into the siding and can also hide insect or termite entry. Recommend correcting this condition(s).

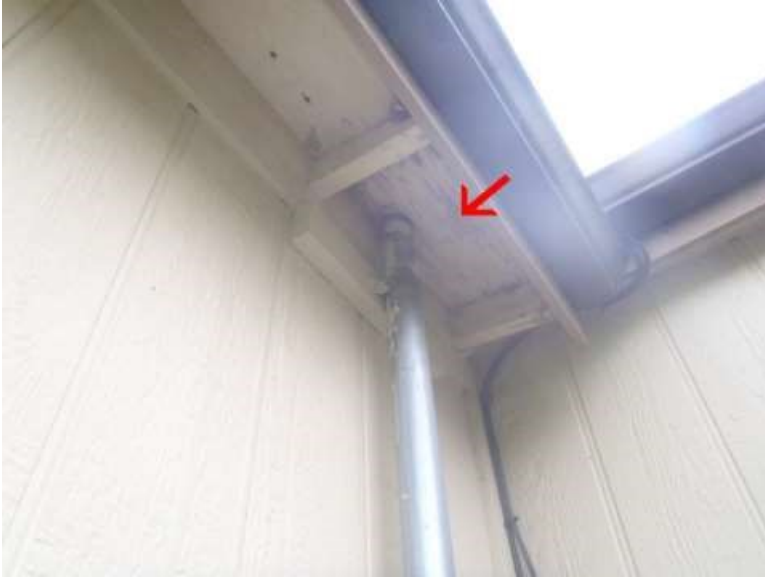
(E) The soffit/eaves appear to be adequate and show only signs of normal wear except there appears to be some moisture damage where under the electric mast. Current leak? Recommend further evaluation/corrections from a qualified specialist. Marked 3 on drawing.

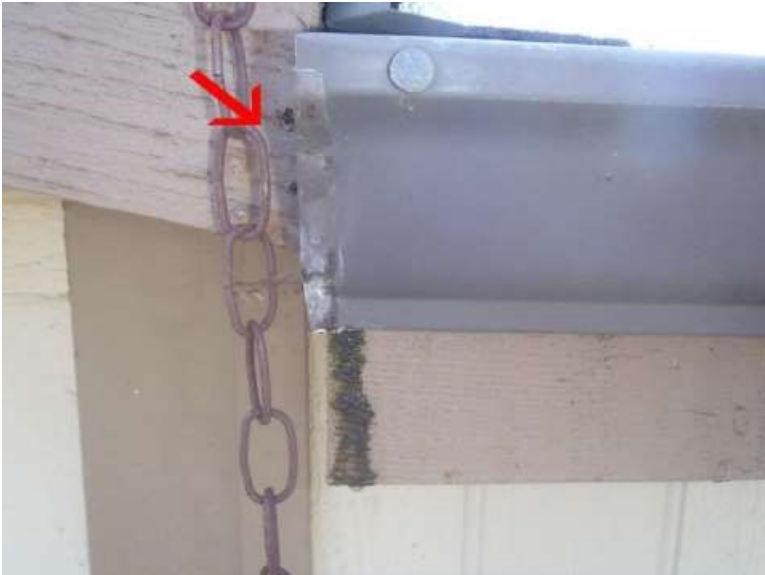
(C) Minor rot at north east corner at gutter leak noted. See roof section. Recommend correcting this condition(s). Marked 2 on drawing.

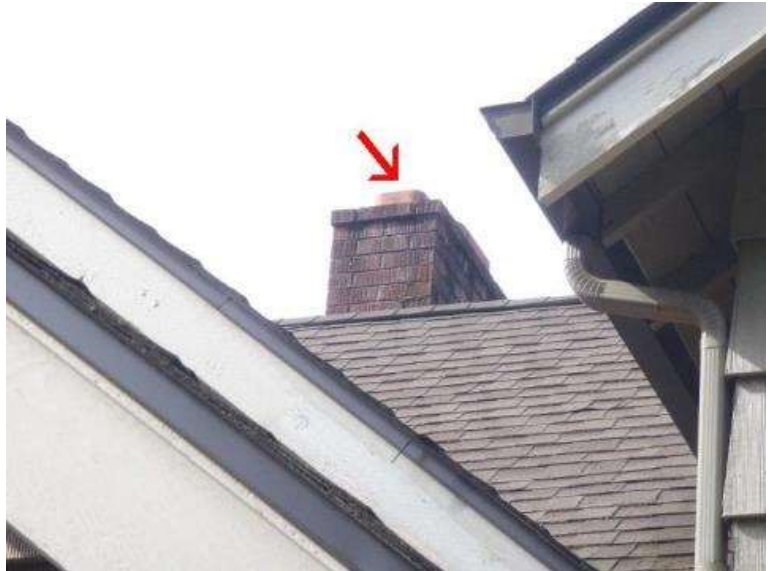
No - There is no chimney cap installed. Installation of a chimney cap is highly recommended to prevent water from entering the masonry stack or entering the wood chase causing deterioration.

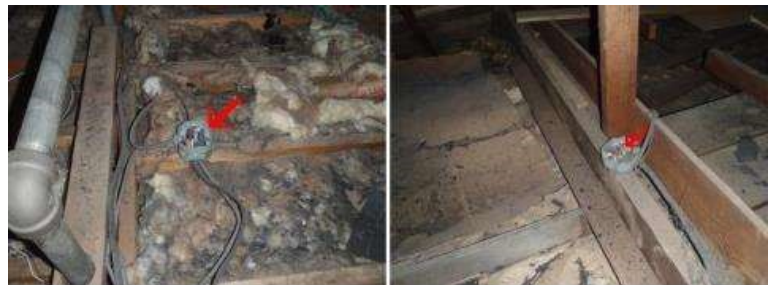
(S) Junction box covers were missing. Recommend correcting this condition(s).

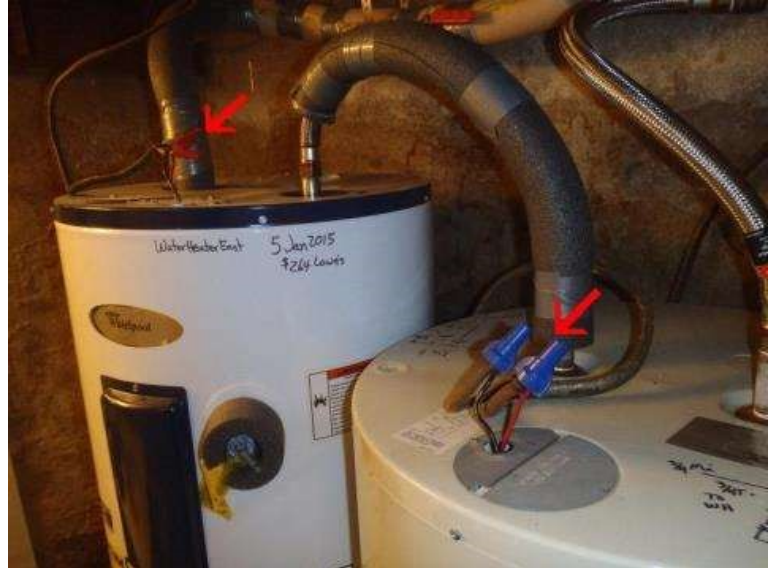
(S) The electric service to the hot water heaters in the bathroom is not installed in an acceptable manner. There are exposed connections. All electrical connections should be done inside a protective junction box.

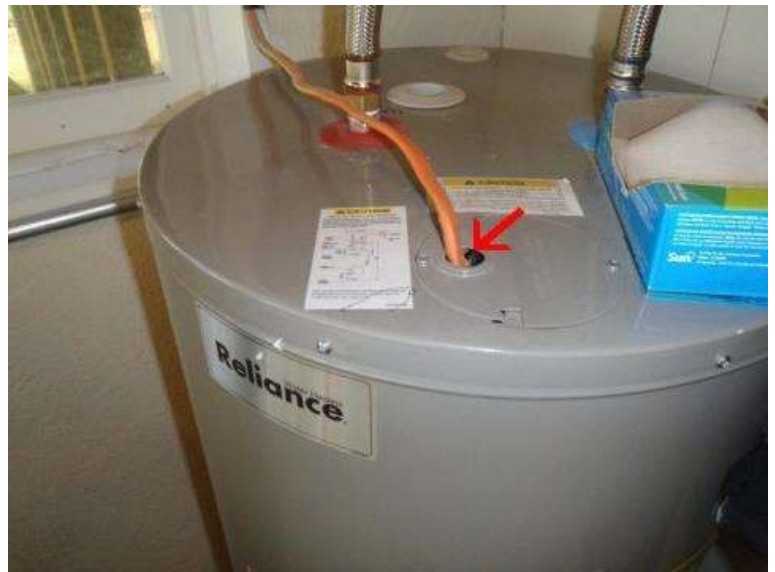
(S) The electric clamp is missing on the laundry room water heater. These conditions are a safety hazard. Recommend correcting these condition(s).

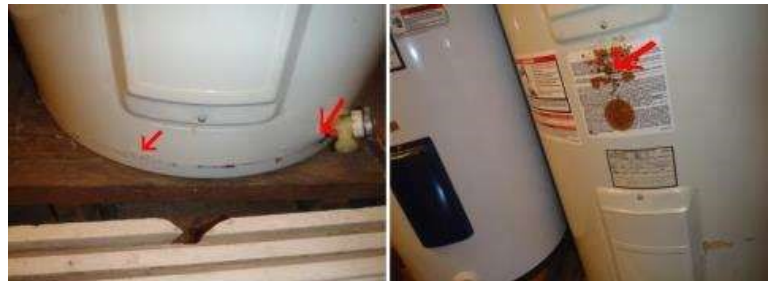
(C) The tanks are not strapped to resist movement. Recommend correcting this condition(s).

(M) Ok except some corrosion on right side water heater in bathroom noted. Recommend monitoring this condition.

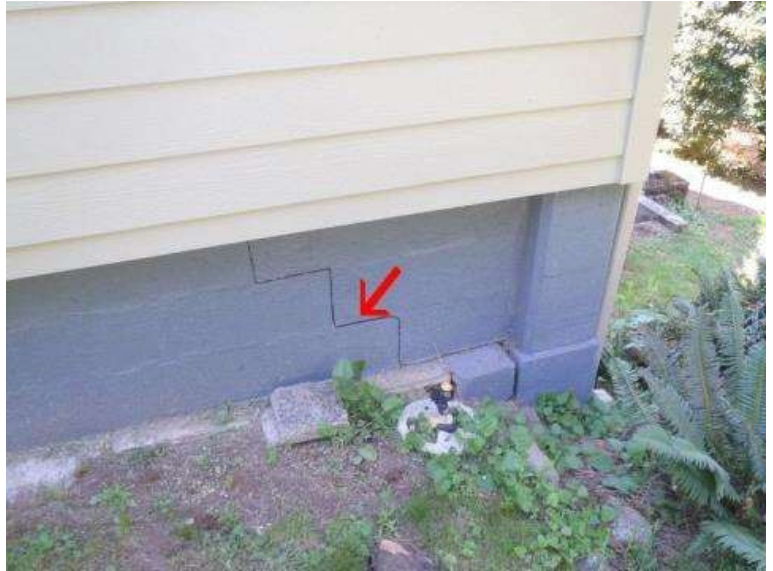
(E) Cracking/separation in foundation walls was noted from the exterior. Recommend further evaluation/corrections by a licensed Engineer if concerned.

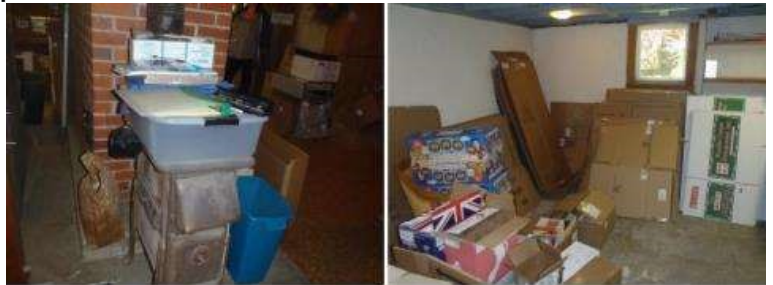
The basement was unfinished but full of stored items or personal belongings. This condition limits the inspection. Recommend re-inspection of basement area after items are moved out and prior to close of escrow.

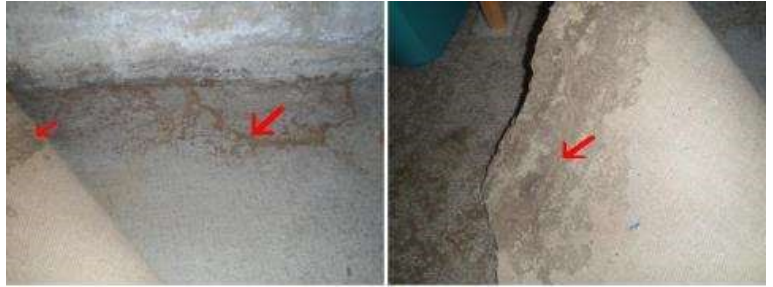
(E) Evidence of subterranean termites were found. Tube debris on floor and under carpet noted. Recommend further evaluation/corrections from a qualified pest control specialist.

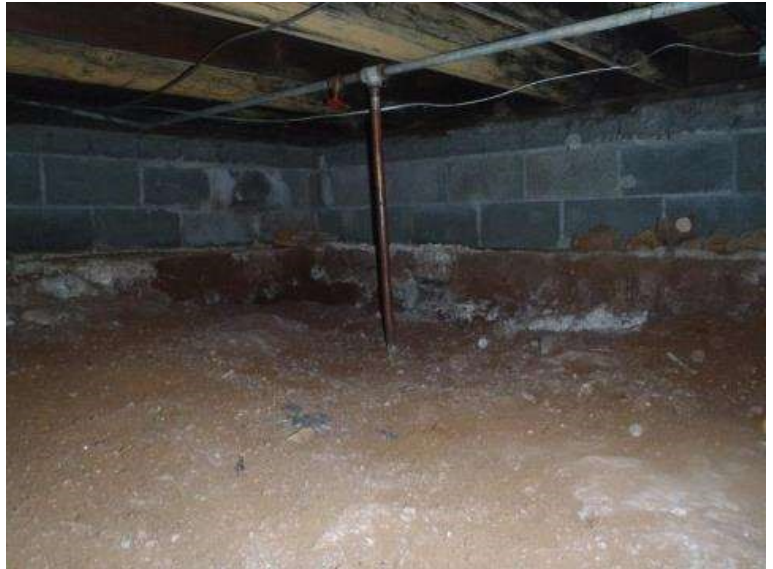
(U) There is no vapor barrier installed. Recommend upgrading this item.

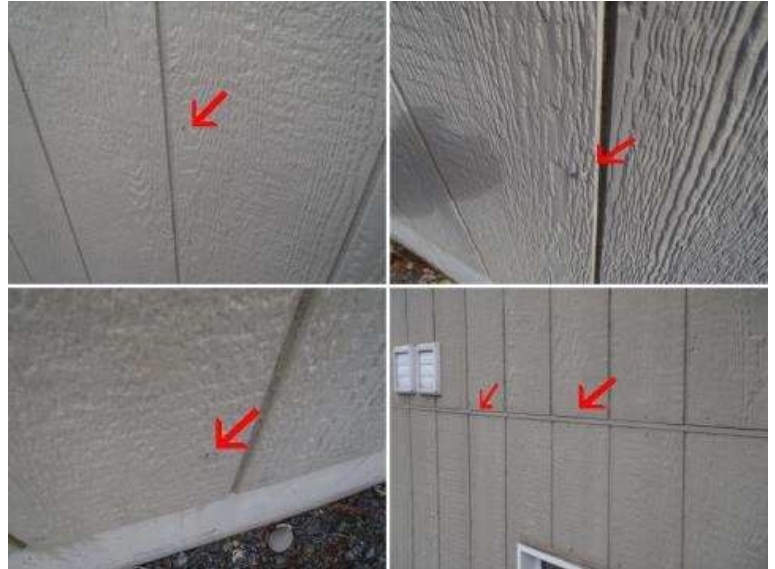
(C) The siding is in serviceable condition except there some inset and popped out nails noted. Recommend correcting this condition(s).

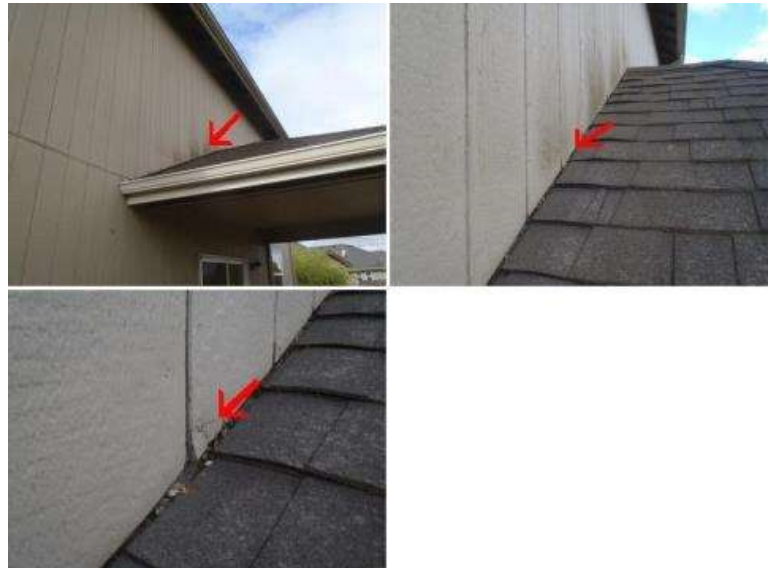
(C) The siding on the north side is dirty and debris build up at wall roof to wall flashing noted. Minor repair noted. Moistures damage from debris build up? Recommend cleaning debris.

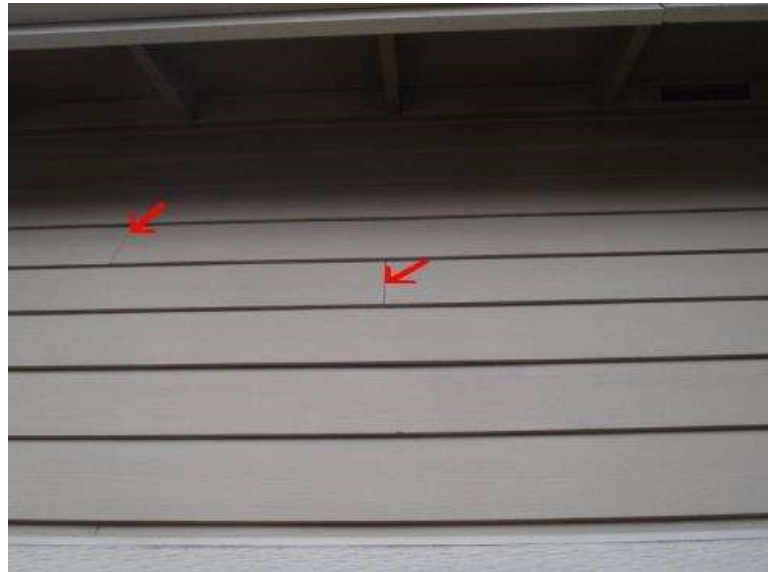
(C) Gaps between the cement boards noted.  
Recommend caulking as needed.

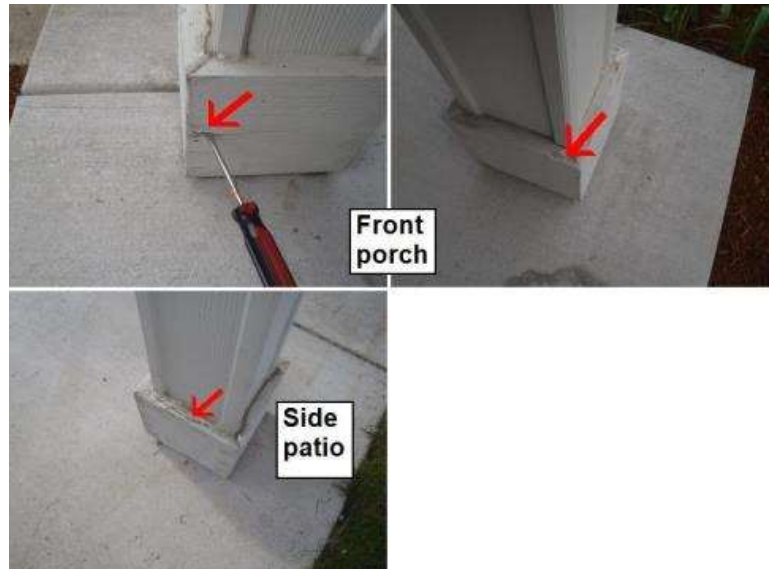
(C) The trim is intact and functional except minor dry rot at front porch post notes. Recommend correcting this condition(s).

(C) Some of the post trim paint is weathered/peeling off.  
Recommend correcting this condition(s).

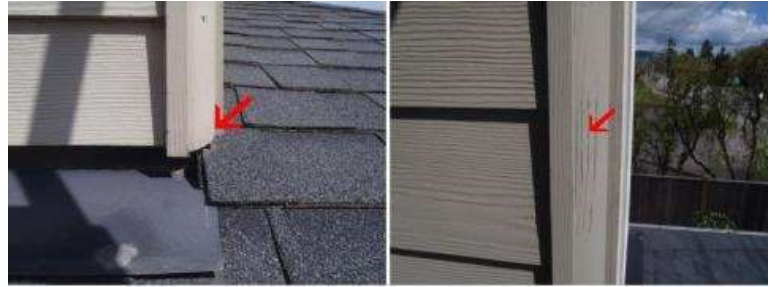
(C) Minor paint cracking noted on upper trim.  
Recommend correcting this condition(s).

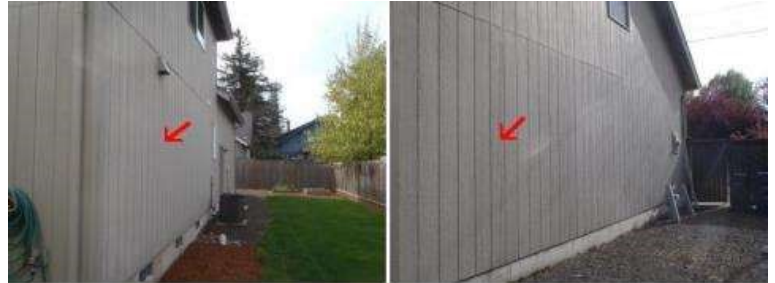
(U) The finish or exposed painted surfaces are functional except the west and south sides are faded.  
Recommend budgeting for paint.

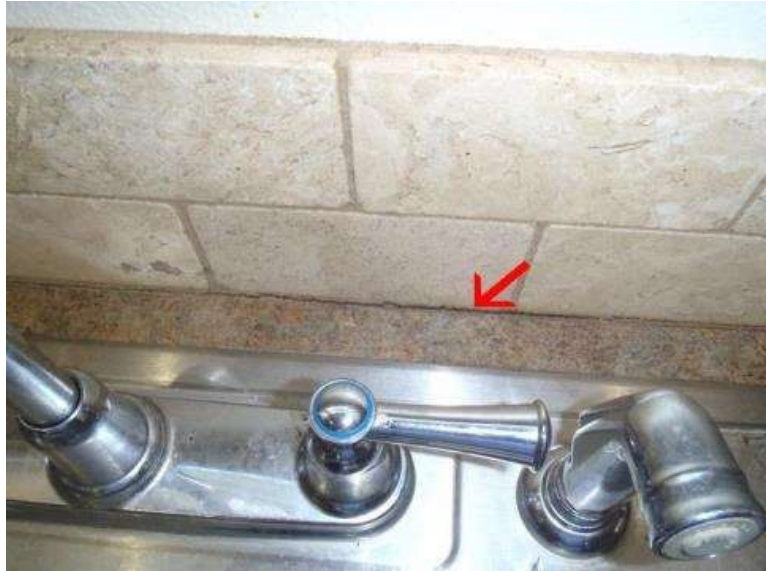
(C) The countertops in the kitchen are functional except the grout needs repaired where the backsplash meets the counter top. Recommend correcting this condition(s).

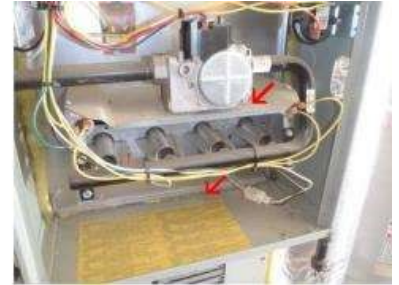
(E) The unit was a little dirty inside. Recommend further evaluation/corrections from a HVAC company if concerned.

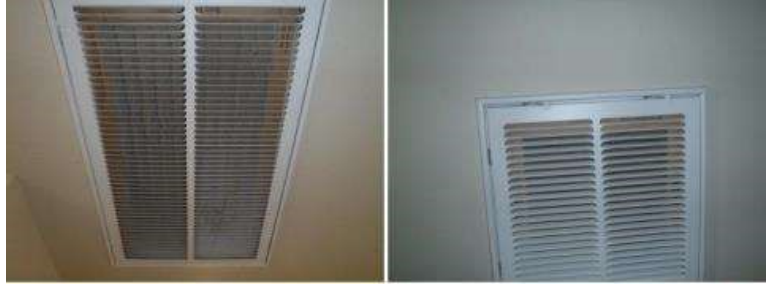
(C) The filters appeared to be dirty. Recommend cleaning or replacing as needed.

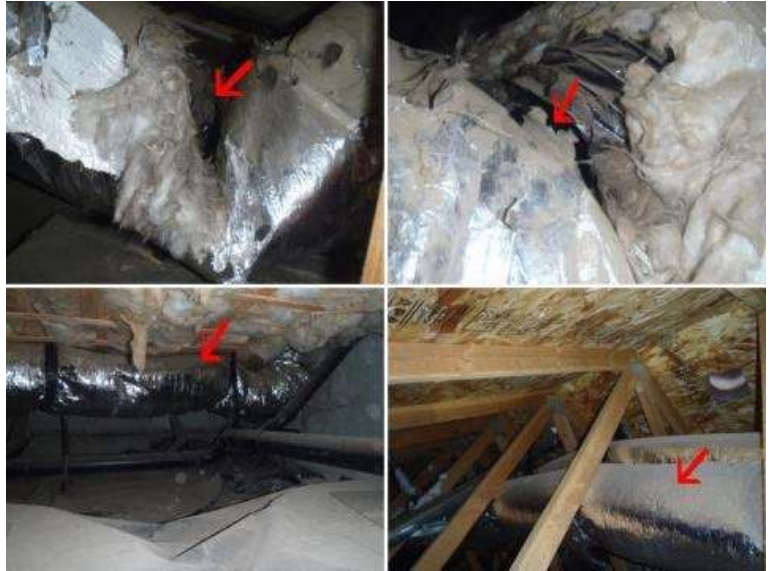
The ductwork appears to be properly installed and supported except one of the ducts in the crawlspace was damaged and a hole was visible. located under southwest corner house. Recommend further evaluation/corrections from a HVAC company.

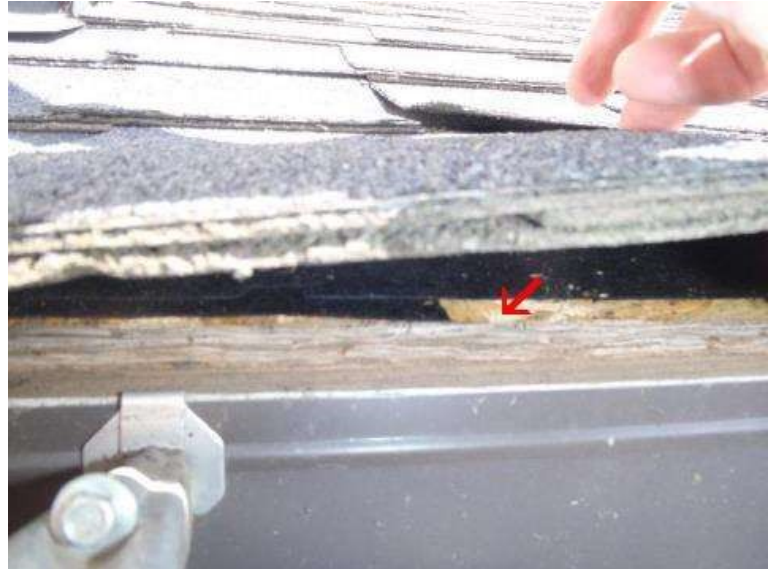
(U) No drip edge flashing installed. this flashing can further protect the roof sheathing. Recommend upgrading this item.

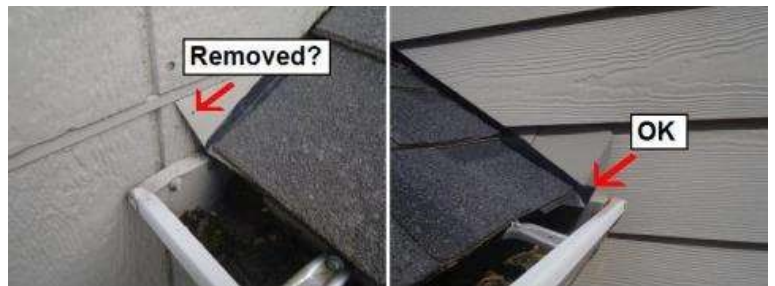
(U) The roof to wall flashings appear functional except the is no kick-out flashing a the porch cover noted. (U)

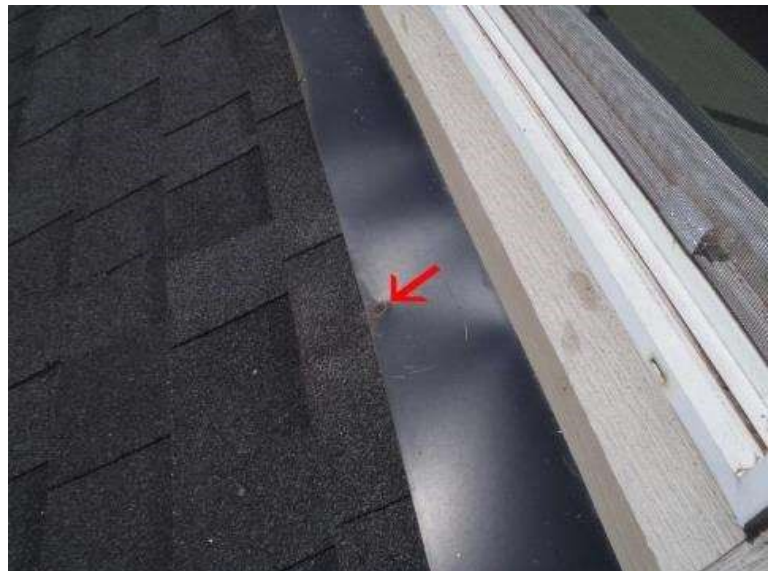
(C) The right side dormer flashing nail wasn't sealed with mastic like the others and it is rusted. Recommend correcting this condition(s).

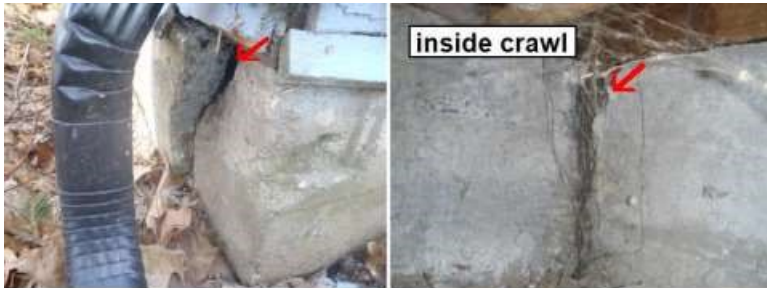
(E) Vertical crack and leaning of east side foundation wall were noted. Conditions exist that warrant further investigation by a Professional Engineer. Seek bids to remedy the condition from at least three (3) Licensed Professional Foundation Contractors. Marked C on drawing.

Typical small/hairline cracks were noted in at least one exterior wall. The larger cracks were in the older foundation.

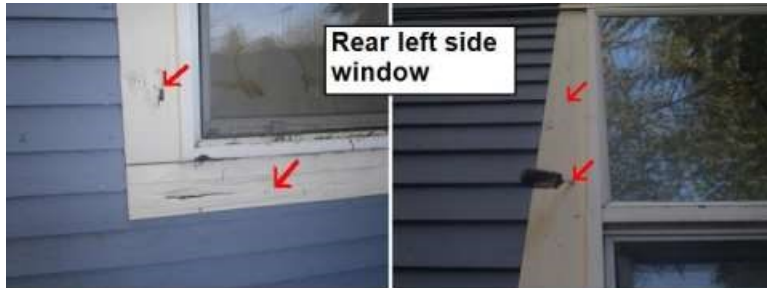
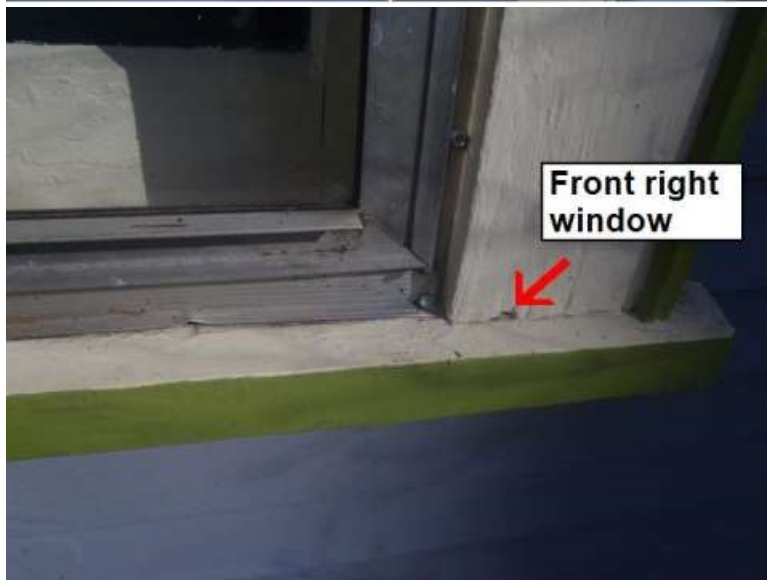
(C) The trim is intact and functional except there is dry in some of the window sills. The trim on the left rear side window is deteriorated to the point that it needs replacement. Recommend correcting this condition(s).

(C) Minor rot in front right window noted. Recommend correcting this condition(s).

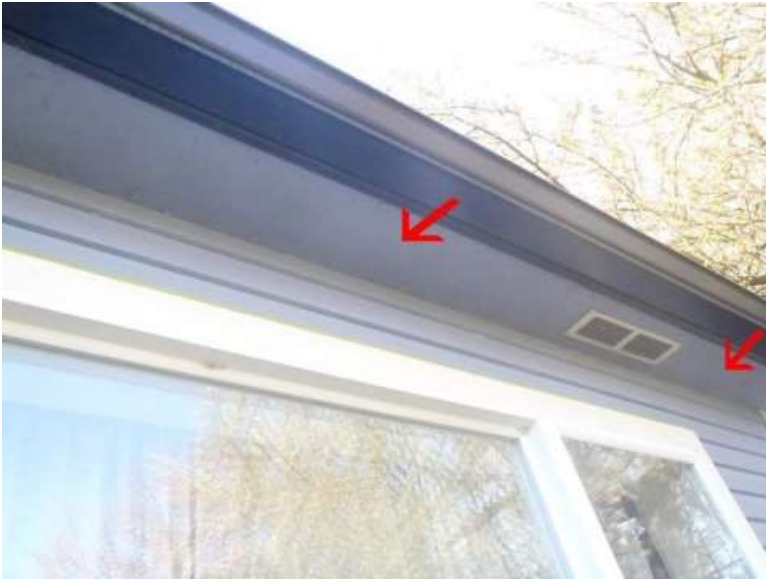
(M) The soffit/eaves appear to be functional except osb was used on the rear eave. This material is painted but is not intended to be left exposed. Recommend monitoring this condition for swelling.

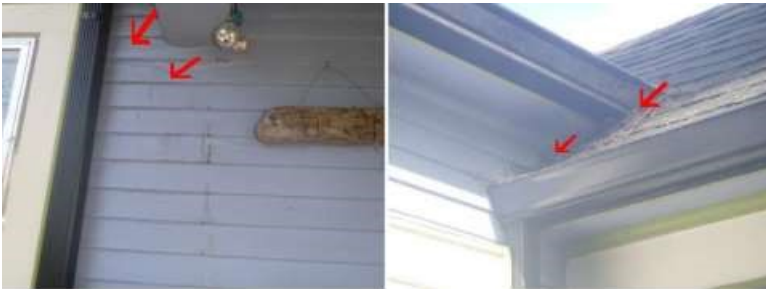
(C) The finish or exposed painted surfaces are functional except there are areas of bubbled paint noted near at the front porch cover. Water may be getting behind the flashing due to debris build up(see roof) Recommend further evaluation/corrections from a qualified specialist.

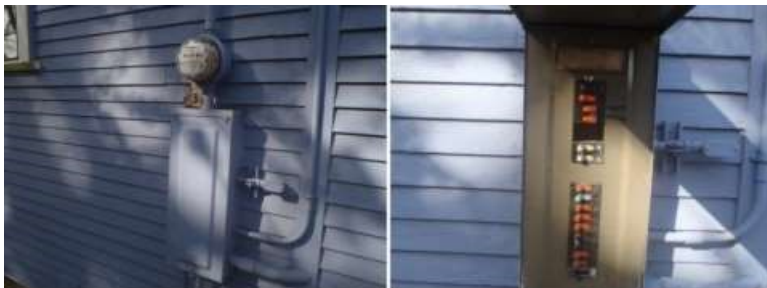
(S) A Zinsco or Sylvania-Zinsco brand electrical panel is installed in this building. Serious electrical hazards may be present in the panel which could result in overheating, fire, or inability to turn off the electric power in the home. We recommend a full evaluation by a licensed electrician who is familiar with this equipment. The panel should be replaced. Additional information about this hazards is available at an independent building failures research website. [www.inspect-ny.com/electric/Zinsco.htm](http://www.inspect-ny.com/electric/Zinsco.htm).

(S) Blanks were missing from the panel. Recommend correcting this condition(s). Circuit and wire sizing correct so far as visible.

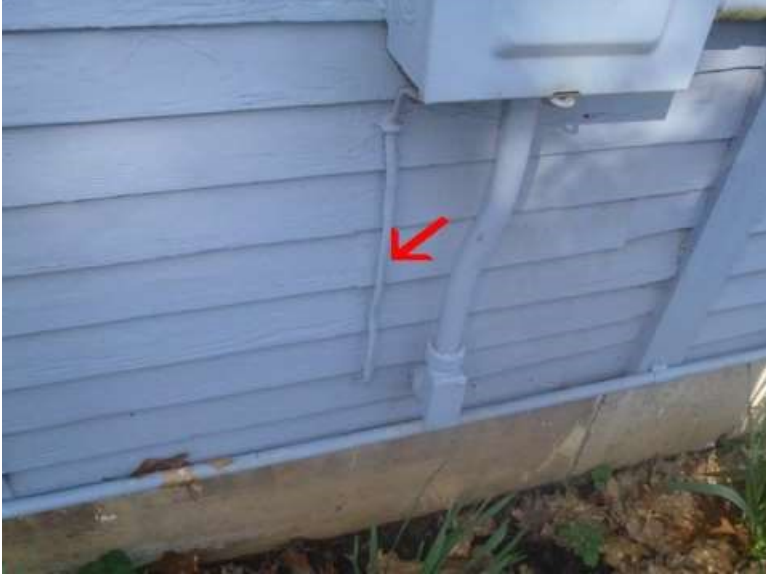
(S) Exposed romex wiring is noted. Recommend exposed wiring be properly protected in approved conduit.

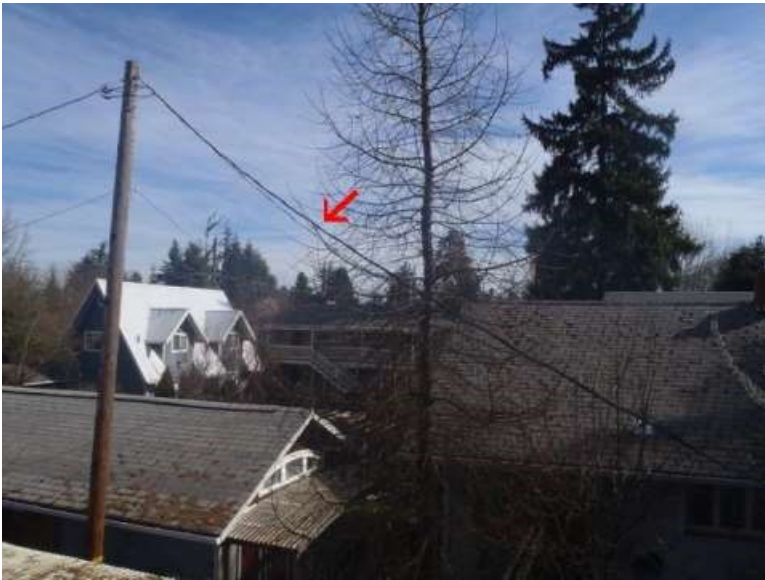
- (C) The overhead wire were in contact with trees. Recommend trimming trees.
- (M) The service conductor wires were showing signs of weathering/wear. Recommend monitoring this condition.
