Inspection: 18009

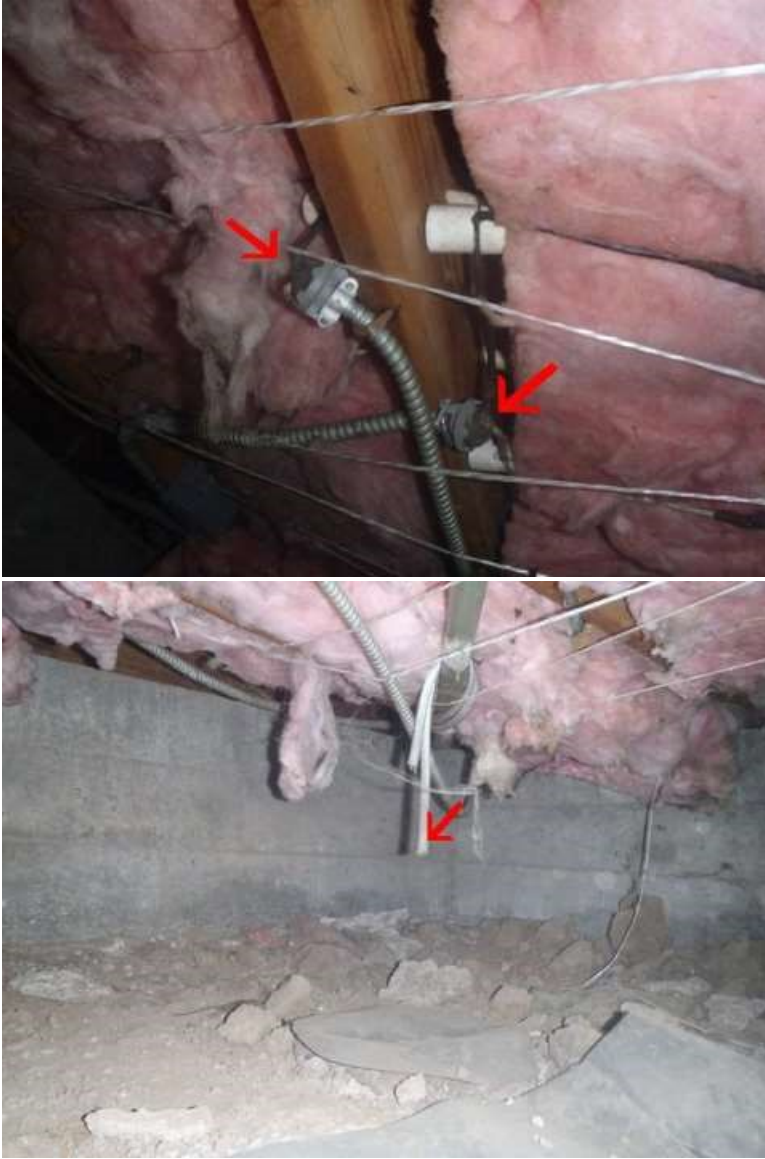
- (S) Old knob and tube wire was noted. It was active and in contact with the insulation. Recommend further evaluation/corrections by a licensed Electrician. Marked E on drawing.
- (S) Dead ended wires noted. If energized they pose a safety hazard. They should be removed or contained in an approved junction box with wires nuts. Marked E on drawing.
